Case History

Rainbow restore Cheddar Gorge shop, who were left in a pickle following a flood

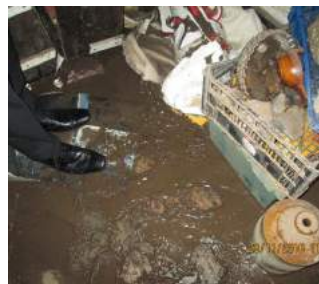
Secured and quarantined area for the Asbestos removal.
